## Sustaining PJ2T for the Next Decade

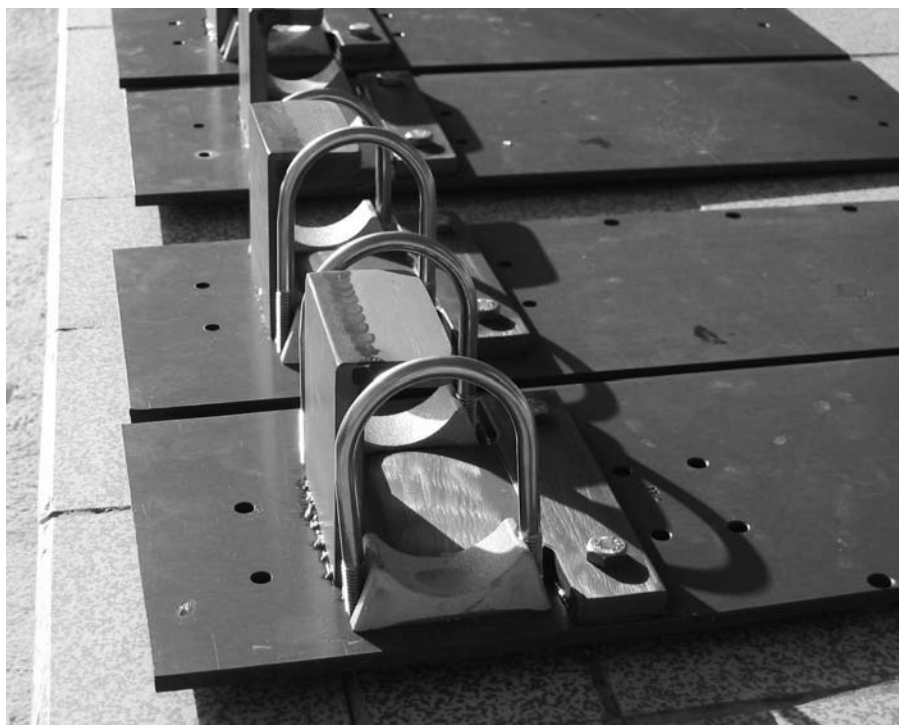
**Figure 2 — Anodized aluminum boom cradles fabricated using DX Engineering parts and homebrew pieces by N8LGP for side-mounting Yagis have survived the severe climate**

Taking down the Yagis, though, turned out to be an even bigger trick than we had imagined. Nearly all of our beams are fixed and side-mounted to avoid rotators and their accompanying failure points. In most cases we used Hy-Gain aluminum boom-to-mast mounts and top-quality stainless bolts to mount the antennas to the tower legs. When it came time to take them down, however, we found that the stainless bolts had totally and irretrievably welded themselves to the Hy-Gain blocks. No amount of torque, pounding or solvent could free them, so we had to cut the bolts with grinders just to get the Yagis off the towers. N8LGP and I designed and fabricated new side-mount saddles consisting entirely of anodized aluminum and stainless parts. These have now been trouble-free for four years.

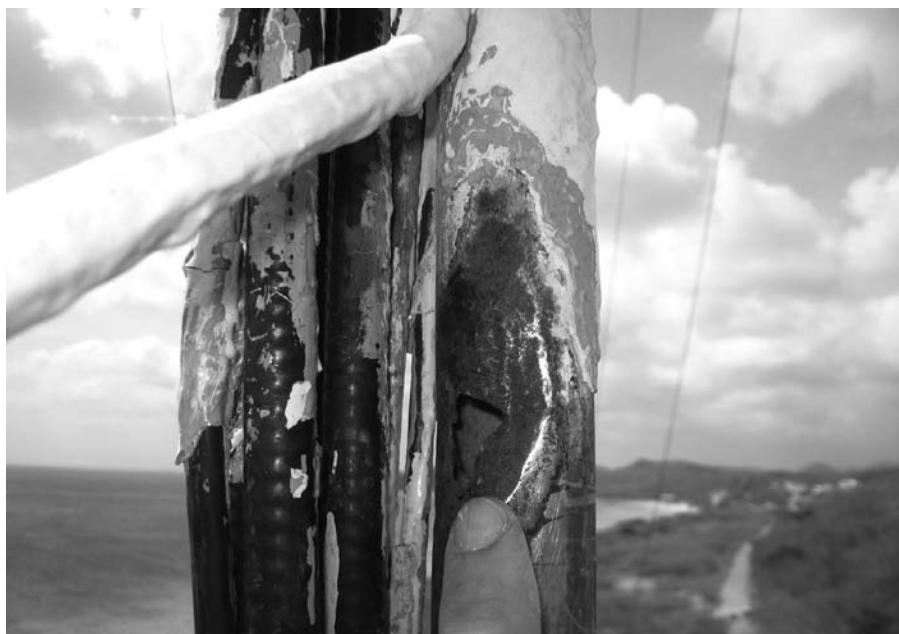
In March 2010, though, I found a particularly ugly-looking rust bloom on a Rohn 55 leg, hidden beneath some cable tape. Digging into that spot revealed a horrifying 5/8-inch diameter hole all the way through the wall of the leg. After cleaning that up as much as possible and power sanding and recoating, we applied a leg splint assembly

**Figure 3 — March 2010: A horrifying hole in a Rohn 55 tower leg that we almost missed. This section was nearly new in 2000 when it was installed. The leg was 100 percent good a few inches above and below the hole.**

that WB9Z had fabricated.

That hole led to a change in tower maintenance philosophy. We dropped the coat-everything philosophy in favor of watching for blooms to poke through and then aggressively attacking those sites with a power sander and grinder, cleaning

down to the bare metal before recoating with epoxy primer and finish coats. This is working well, and we're confident that this approach, coupled with continuing aggressive inspection of guy wire assemblies, will keep the towers in the air for another 10 years.

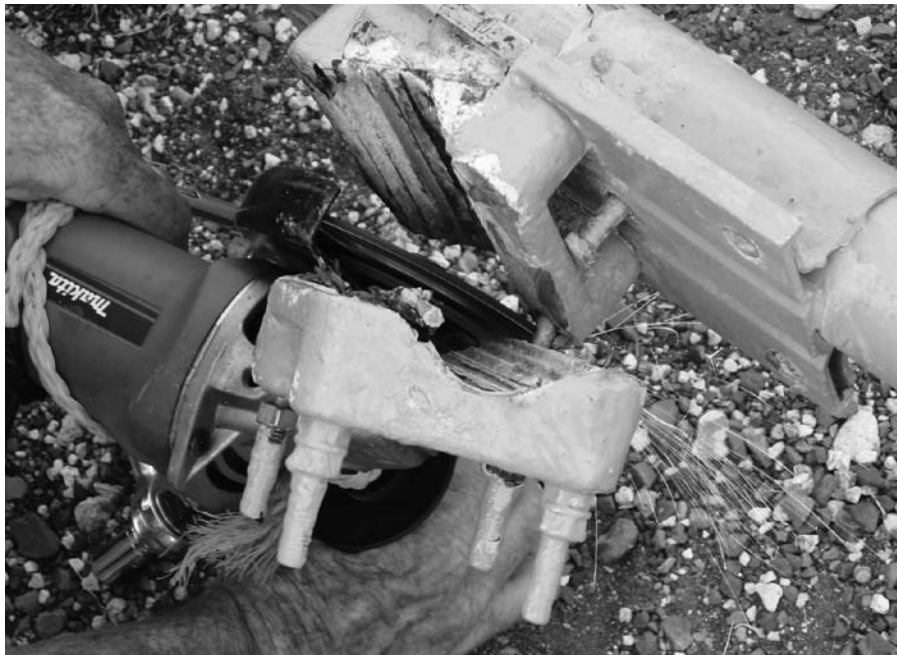
**Figure 4 — Cutting apart totally fused stainless bolts and a Hy-Gain boom-to-mast mount. We had to do this to five similar assemblies at PJ2T in order to get them off the towers.**

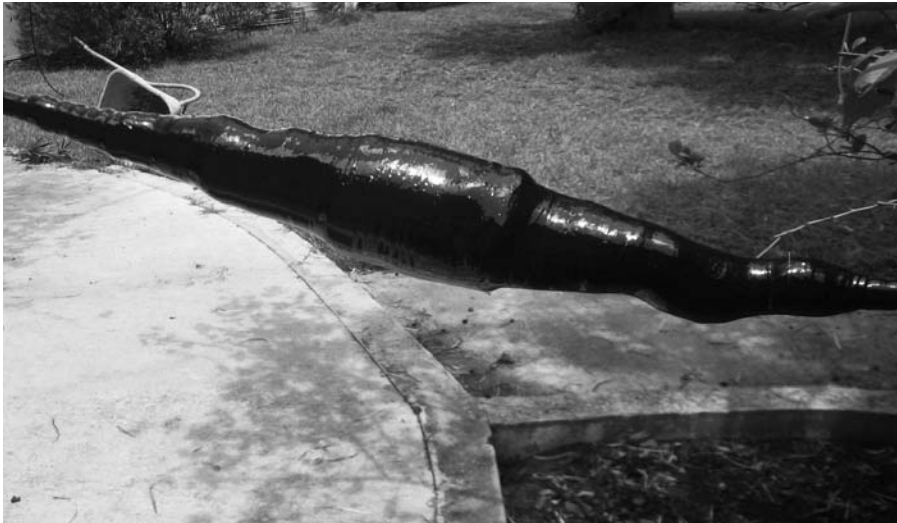
**Figure 6 — This joint between Phillystran and a quarter-inch EHS guy wire tail contains a large egg insulator. All parts have been painted with epoxy, totally encapsulated in duct seal putty, wrapped in Scotch 33 tape and varnished.**

Since experiencing guy anchor and dead end rust in 2001 to 2003, we replaced every dead end and installed quarter-inch EHS cable and, in some cases, new turnbuckles. After assembling the guy tails, we paint the steel guy wire with a coat of epoxy primer and a finish coat of epoxy finish, and then wrap the entire length in Scotch 33, finishing up with a coat of varnish on the tape. Same with the dead ends. The egg insulator and turnbuckle assemblies are completely encapsulated in duct seal putty, taped with Scotch 33, which then is varnished. The proven principle is that if we can keep the salt-laden water micro-droplets from contacting metal, then all will be well.
